## 2.2 The Old Vicarage

## 3 Description

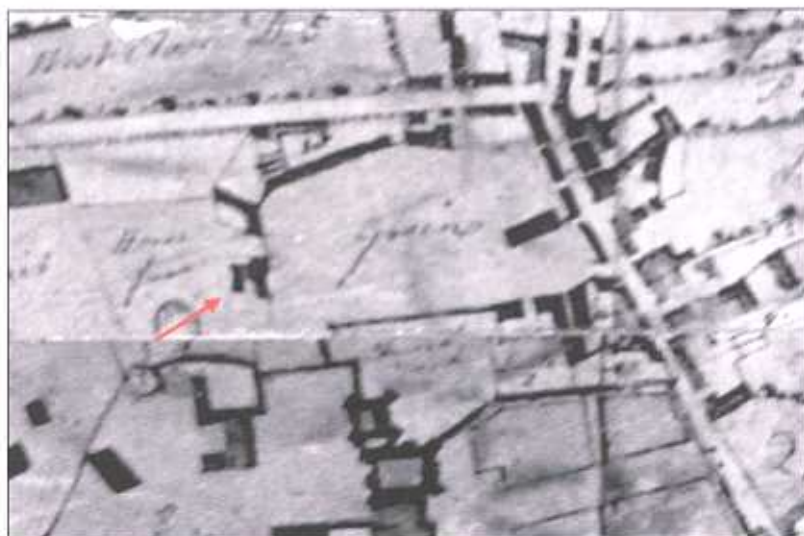
**Figure 2:** Extract from the 1767 map of the manor of Elstow (BLARS, X1/6/1)

The first map evidence for 'The Old Vicarage' can be found on the 1767 map of the manor of Elstow (Fig. 2). The house (marked with a red arrow) faces on to the green and has an L-shaped projection to the rear. The house appears to have an area of land to the rear (west) and is labelled Hords? Farm; thus confirming its likely use as a farmhouse. No farm buildings associated with the house are shown on this map. The 'Green' is labelled on the map and the Moot Hall on the east side of the Green can be seen.

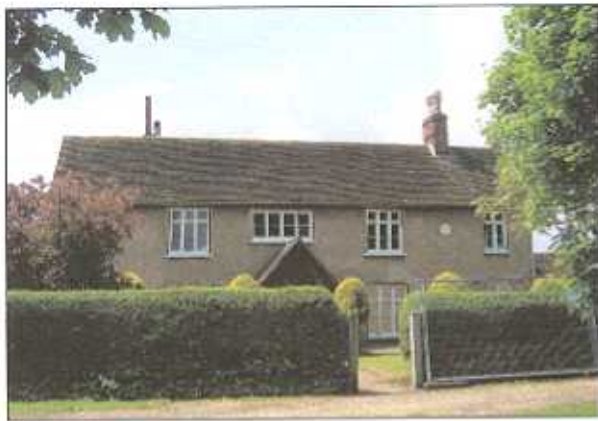
Pebbledash render on timber laths over timber frame and red brick (small area of brick and timber frame exposed at time of survey). There are a series of nineteenth century casement windows on the front elevation with thick timber mullions and transoms. At first floor level is a circular stone plaque which reads 'S.W 1796' (Fig 7). There is a large projecting timber gabled timber porch with a clay tile roof (late nineteenth / early twentieth century), it is open at the front and part of the sides, next to the house it is enclosed with windows either side and a front door. The early nineteenth century moulded door case with a broken triangular pediment has been retained within the later porch. Windows have been inserted either side of the front door. The timber door dates to the late nineteenth century but has a large frosted glass pane inserted into its upper part. Small black and white geometric tiles to porch floor. At the north end of the east elevation and set well back from the front is the nineteenth century two storey painted brick extension with a single storey painted brick extension attached. Two timber doors lead to the kitchen and store room. A water pump is located just outside the kitchen door; it dates to the nineteenth century and has a stone basin.

**Figure 6:** Front (east) elevation

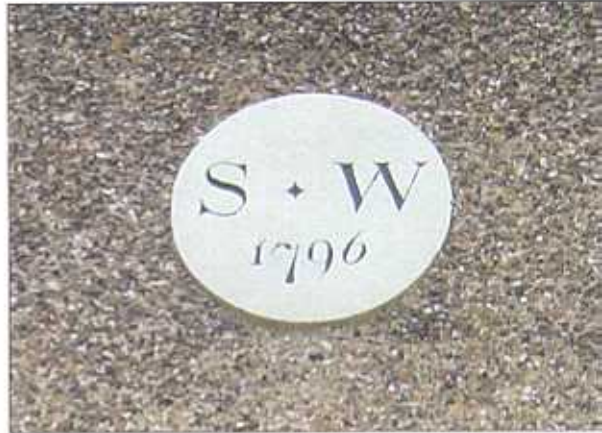
**Figure 7:** Circular plaque on front (east) elevation

There is a small circular plaque on the front elevation of The Old Vicarage which reads S.W 1796. This may refer to either the purchase of this property or its alteration / remodelling by the Whitbread family. Samuel Whitbread (SW) acquired the Manor of Elstow in 1792; he then purchased other parcels of land in Elstow between 1792 and 1796, the year he died. The nearby village of Cardington contains a number of houses bearing plaques with the initials SW; these were built by Samuel Whitbread who was born at Maltings Farm, Cardington.

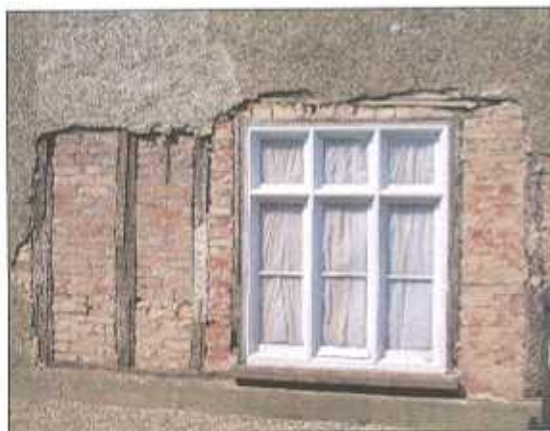
**Figure 8:** Front (east) elevation, exposed timber frame and brick

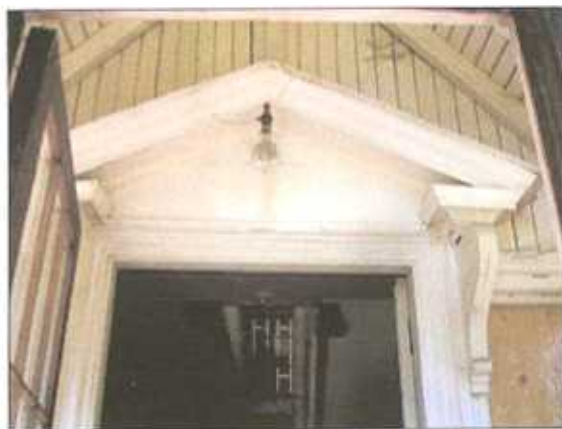
**Figure 9:** Front (east) elevation, early nineteenth century door case within porch

East elevation: Late nineteenth century front door, modern glass pane inserted in upper part. The doorway has a moulded surround (early nineteenth century) and an old stone step. Either side of the door are two windows (late nineteenth / early twentieth century), probably inserted when the porch was constructed to give more light to the hallway.

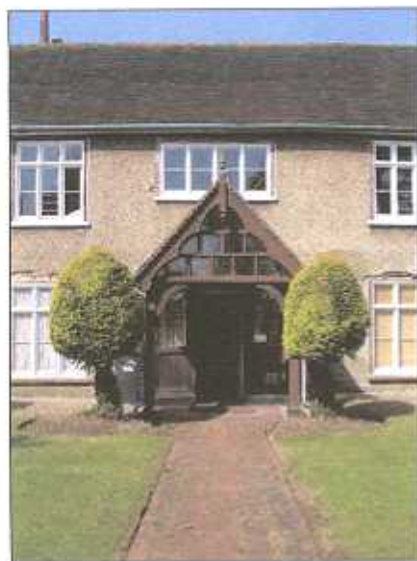
**Figure 10:** Timber porch to front (east) elevation

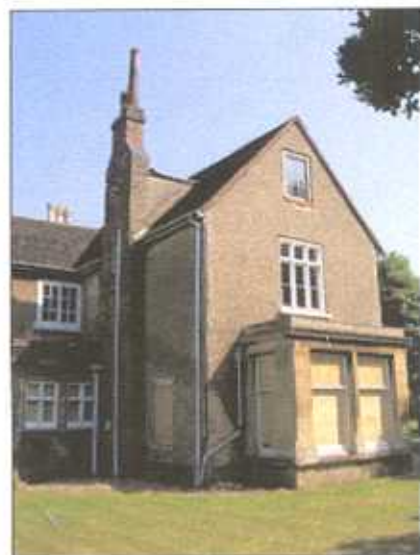
Timber frame and brick gable end, pebbledash rendered. Projecting rectangular, single storey, flat roofed stone bay containing four 1-over-1 sash windows (late nineteenth century). Timber casement window at first floor level, 9-pane garret window above (early nineteenth century).

**Figure 11:** Side (south) elevation

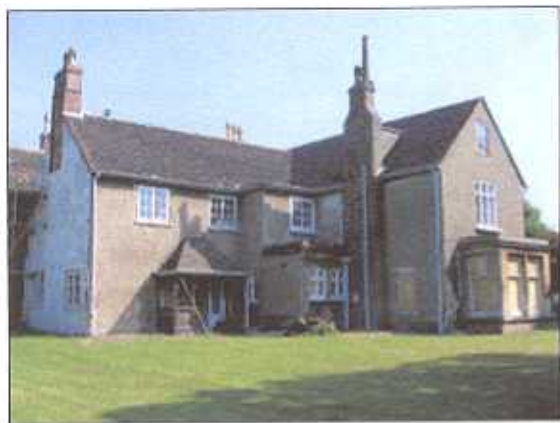
**Figure 12:** View of the property from the south-west

At the south end of the west elevation the walls are timber frame and brick covered with pebbledash render, attached is a nineteenth century yellow brick chimney stack. The principal projecting gabled rear wing is also brick and timber frame covered with pebbledash render. To the north of the principal projecting wing are two gabled brick wings dating to the mid to late nineteenth century. The stock brick is laid in Flemish bond; the timber casement windows have brick arches and stone sills. Also attached to the rear elevation is a small flat roofed brick extension which contains open brick arches at ground floor level. There are a series of nineteenth and early twentieth century timber casement and sash windows.

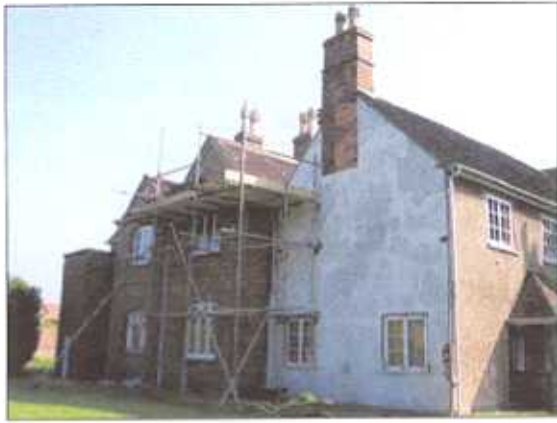
**Figure 13:** Rear (west) elevation

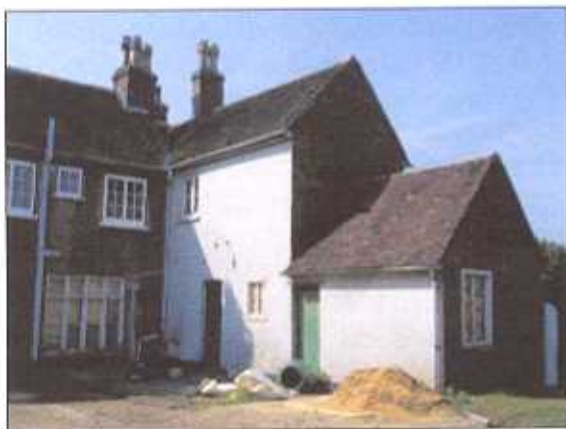
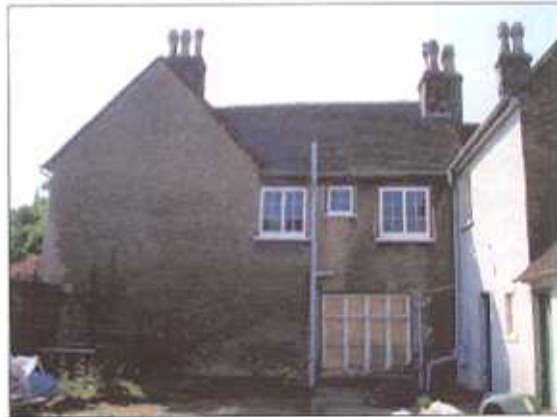
The gable end of the front elevation with its projecting rear wing is visible, pebbledash render over brick. To the west is the nineteenth century gabled brick wing which continues to the north, attached to the north of this is a gabled single storey brick extension.

**Figure 14:** Side (north) elevation

**Figure 15:** Side (north) elevation

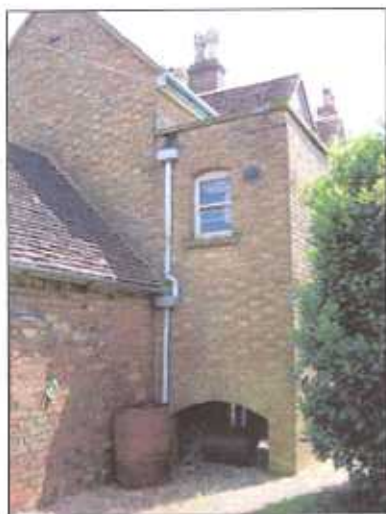
**Figure 16:** North end of the rear (west) elevation

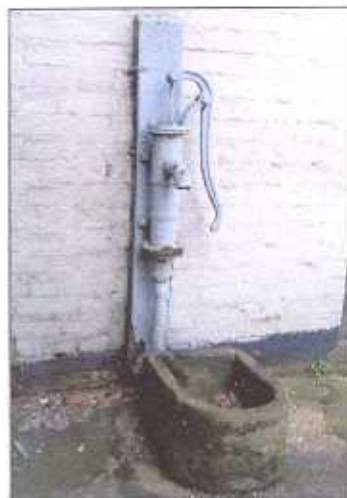
**Figure 17:** Water pump outside kitchen door

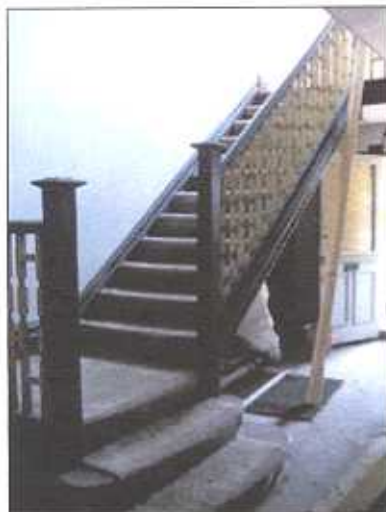
The staircase up to first floor is set against the north wall; it is wide with chunky square cut newel posts, fretwork balusters and a timber handrail. The two curtail steps are curved, these rise to the north at which point there is a small quarter landing, the staircase then returns to the east and rises up to the first floor.

**Figure 18:** Room 1. Staircase in hall

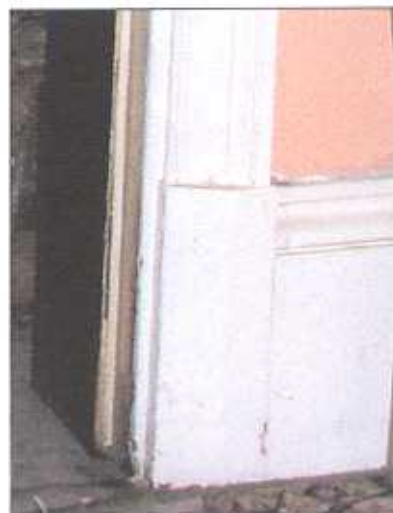
**Figure 19:** Room 2, sitting room. Detail of skirting board and un-moulded plinth to door surround

North elevation: Plastered brick with a nineteenth century 4-panel door within a moulded surround leading to the hall (room 1). The surround has an angled unmoulded plinth, a high status feature.

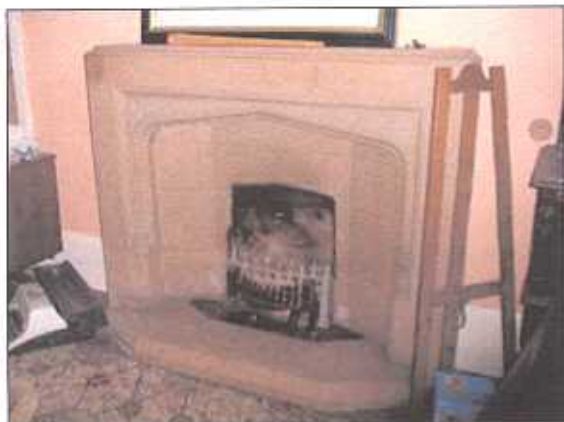
West elevation: Plastered brick wall, carved stone fireplace, late nineteenth / early twentieth century. A bell push is sited just to the north of the fireplace. To the south is an early twentieth century single pane window.

**Figure 20:** Room 2, carved stone fireplace

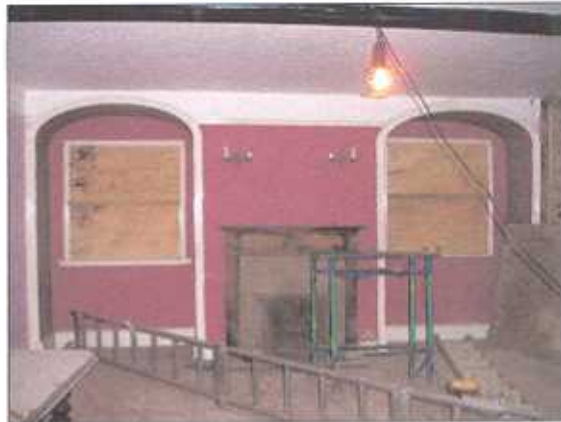
**Figure 21:** Room 4, fireplace and arched niches

West elevation: Rendered brick chimney breast. Central cast iron fireplace with a timber surround. Two niches with moulded timber surrounds, one either side of the chimney breast, contain nineteenth century timber casement windows.

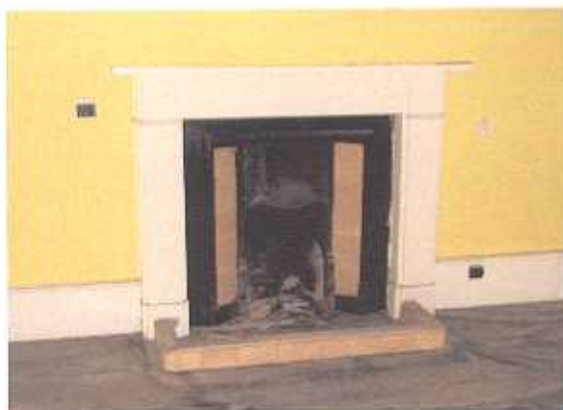
**Figure 22:** Room 5, fireplace

North elevation: Brick wall, plastered. Fireplace in centre, timber surround with cast iron grate and tiled cheeks; tiled hearth with raised tiled surround (late nineteenth century). Bell push to side of fireplace.

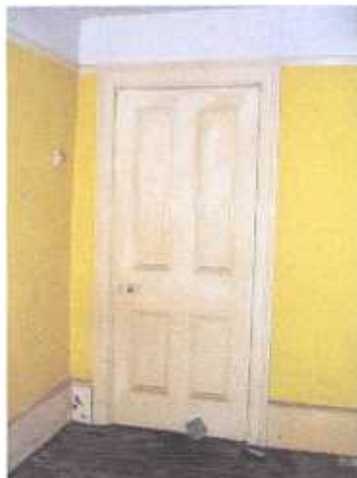
**Figure 23:** Room 5, 4-panel door with moulded surround, roll-moulded skirting boards and picture rail

Deep moulded skirting boards and picture rail (nineteenth century) to all elevations.

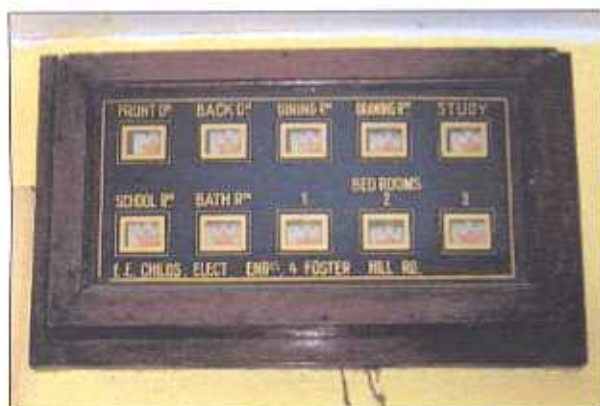
**Figure 24:** Room 6, staff room. Early twentieth century indicator board for call bell system

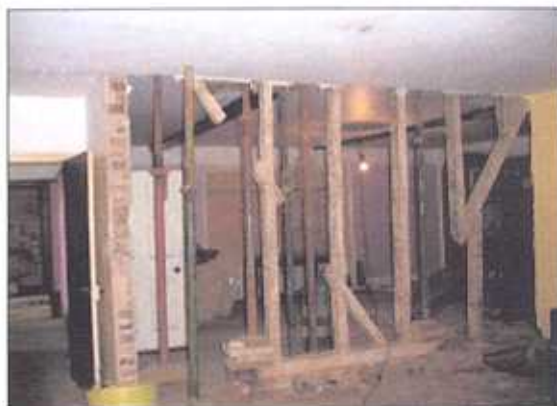
**Figure 25:** Room 6, staff room. Timber frame to south elevation

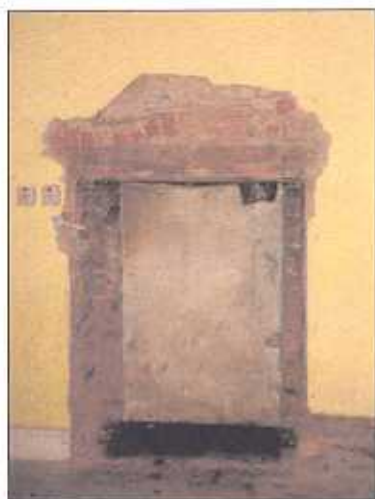
**Figure 26:** Room 6, staff room. Brick fireplace

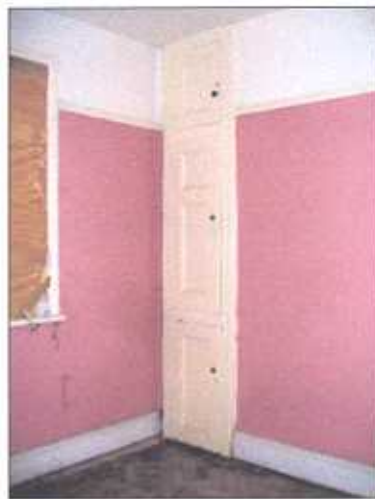
**Figure 27:** Room 7, sitting room. Tall timber cupboard in north-east corner

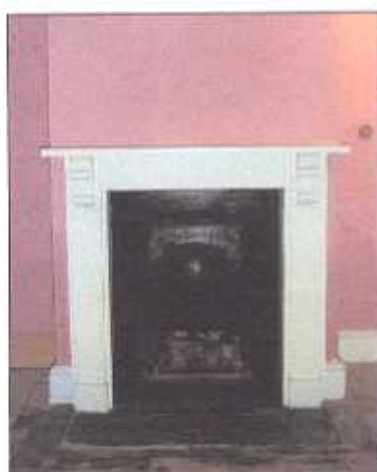
**Figure 28:** Room 7, sitting room. Nineteenth century fireplace

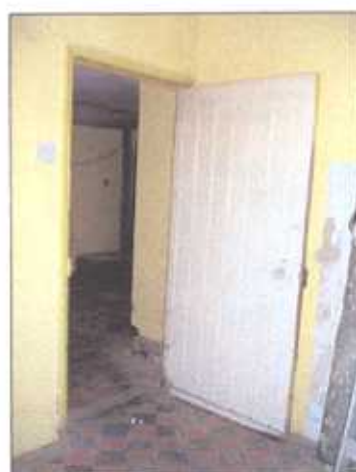
**Figure 29:** Room 9, kitchen. Door to staff room

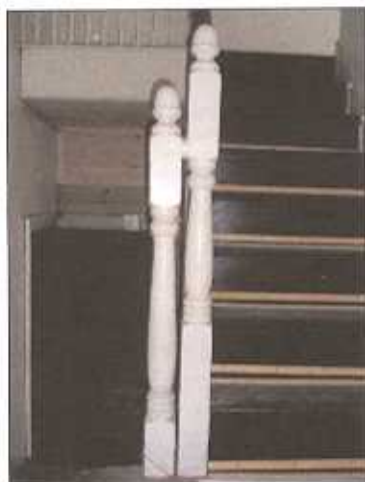
**Figure 30:** Room 10, turned newel posts at base of staircase (nineteenth century)

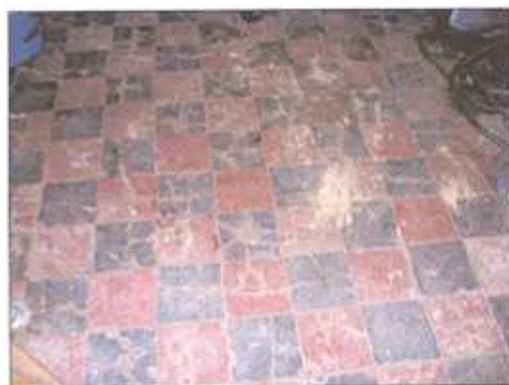
Floor: Red and black geometric tiled floor (nineteenth century).

**Figure 31:** Room 11, store. Nineteenth century black and red quarry tile floor

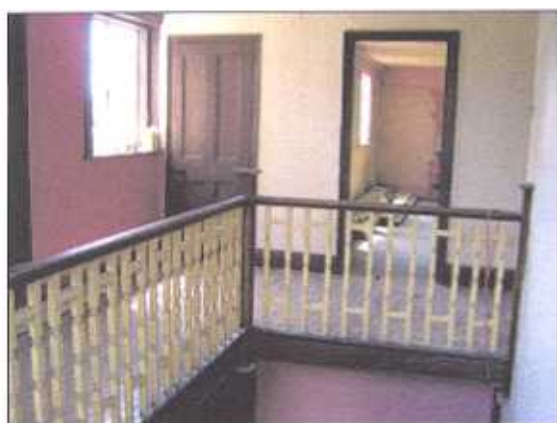
**Figure 32:** Room 12, landing. Fretwork balusters to staircase (late nineteenth / early twentieth century)

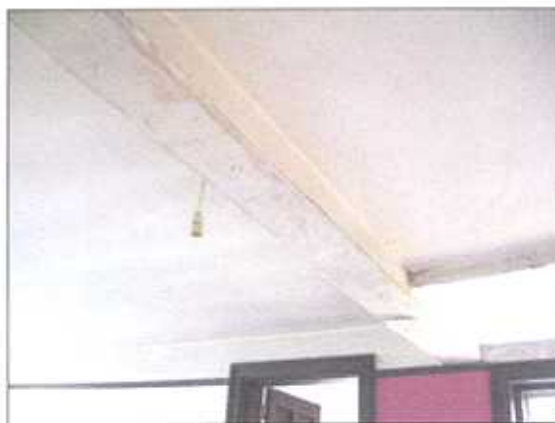
**Figure 33:** Nineteenth century roll moulded timber beam running north to south to west end of landing

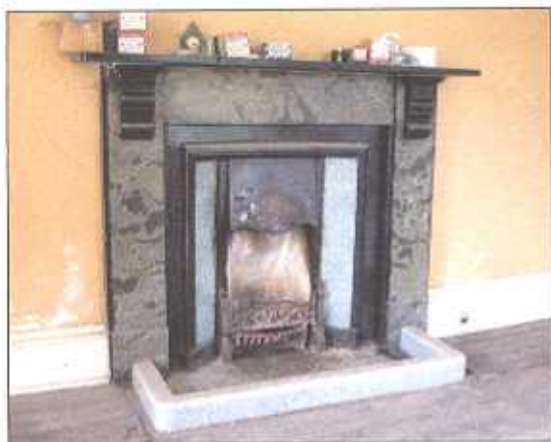
West elevation: Plastered brick wall. Cast iron fireplace with green and black marble surround, tiled cheeks and raised ceramic tile surround.

**Figure 34:** Room 13, bedroom. Cast iron fireplace with marble surround.

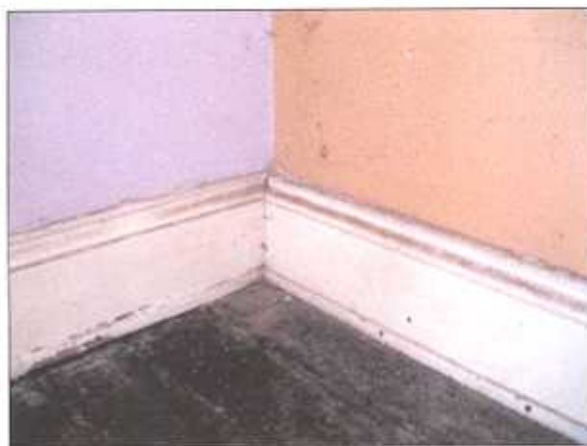
**Figure 35:** Room 13, bedroom. Deep moulded skirting boards

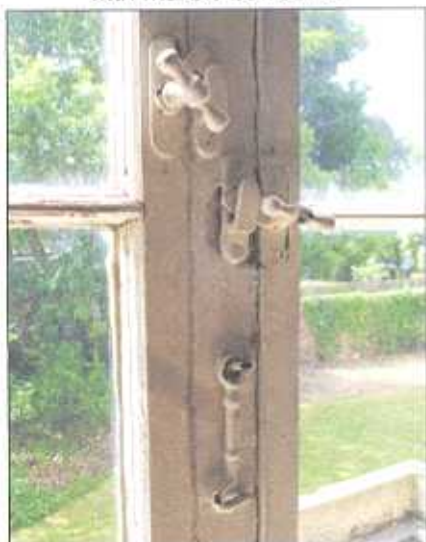
**Figure 36:** Room 13, bedroom. Window catches, late nineteenth century

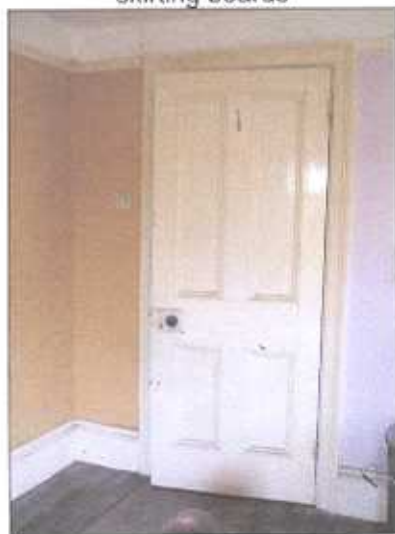
**Figure 37:** Room 13, bedroom. 4-panel door leading to landing

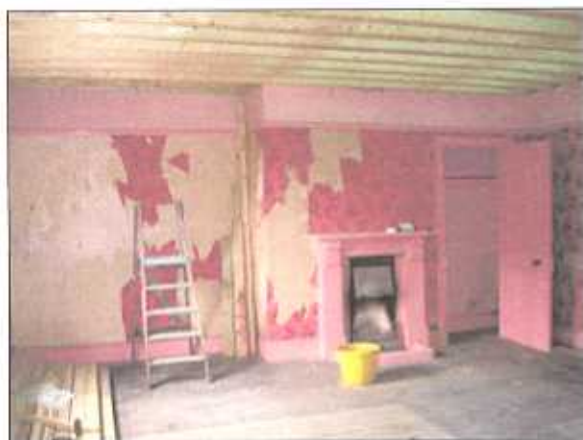
**Figure 38:** Room 14, bedroom – west elevation

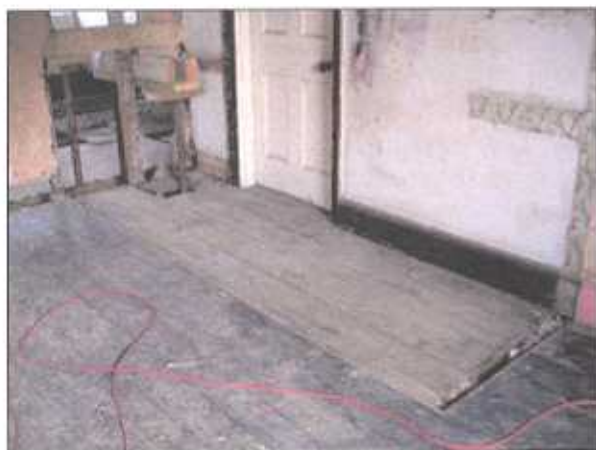
Floor: Pine floorboards (late nineteenth century). The floorboards which were once inside the cupboard are wider and older, dating to the early nineteenth century.

**Figure 40:** Room 14, bedroom. Older pine floorboards retained in cupboard (cupboard walls removed)

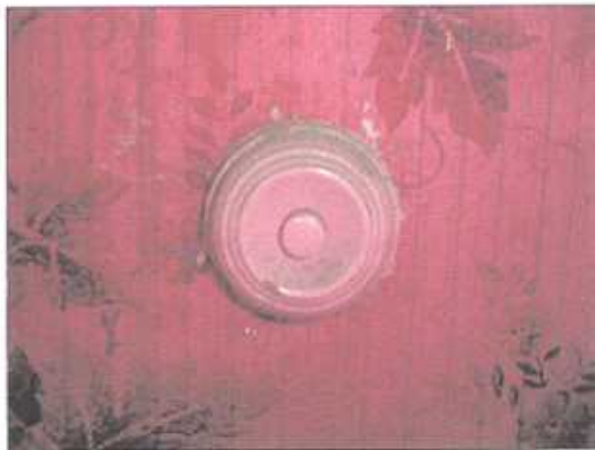
**Figure 41:** Room 14, bedroom. Bell push on north elevation

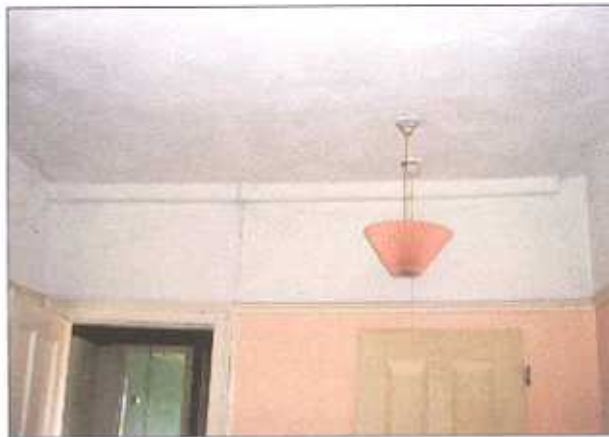
**Figure 43:** Room 16, nursery. Timber beam visible running along the top of the wall.

South elevation: Brick chimney stack projects into the room, small ornate cast iron fireplace with a plain timber surround and a stone / slate hearth (placed off centre). A 4-panel door with a moulded surround to the east of the chimney breast leads into room 15 (bedroom).

West elevation: Plastered brick wall, a 4-panel door with a moulded surrounds (nineteenth century) leads to room 17. Part of a timber beam is visible running along the top of this wall.

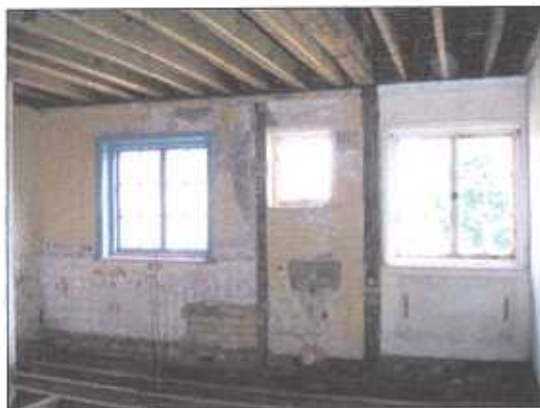
**Figure 44:** Room 17, north wall

North elevation: Rendered brick wall, three early twentieth century casement windows with early twentieth century catches / stays.

This room was, until very recently, subdivided by block work walls to form a bathroom, W.C. and cupboard with two corridors to rooms 16 and 18. At the time of the survey these mid twentieth century block work walls, the floorboards, skirting boards and ceiling plaster were removed.

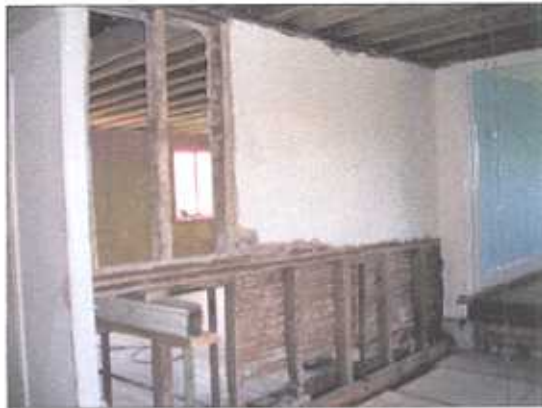
**Figure 45:** Room 17, south wall

South elevation: Timber frame, lath and plaster wall (lath and plaster partially removed).

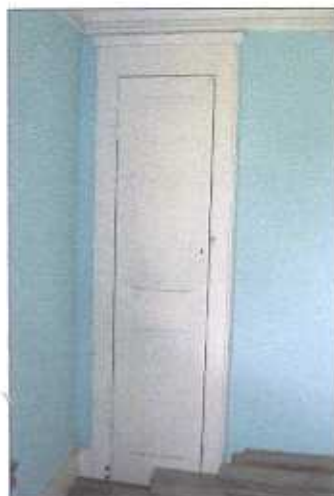
**Figure 47:** Room 18, bedroom. Narrow timber cupboard

North elevation: Plastered brick wall. Tall, narrow cupboard at the west end, 2-panel door, nineteenth century. At the east end is a 4-panel door with moulded surround leading out to the landing.

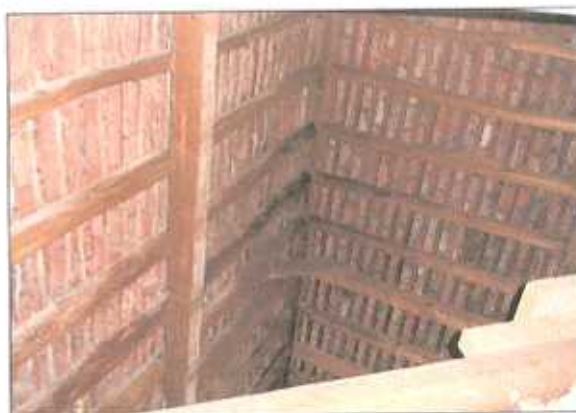
**Figure 51:** View into roof space from room 14

The roof space / attic was not accessed during this survey, however views of part of the roof structure were obtained as the lath and plaster ceilings have been removed in rooms 14 and 17. The roof structure appears to date from the late nineteenth or early twentieth century, the timbers are square cut and uniform. The rafter roof has side purlins and a ridge plate. The roof level above the front range of the property contains a fireplace (D Olney, pers. comm.), and has been divided by partition walls. A garret window is also visible on the southern gable end.
